Incidence of Corrosion on Electric Power Losses in ACSR Cables

Carlos G. Cárdenas^{1*}, Oscar M. Pardo¹, Edward Barajas¹ y Alfonso Santos²

¹Ingeniería Electromecánica, Universidad Antonio Nariño, Bucaramanga, Colombia

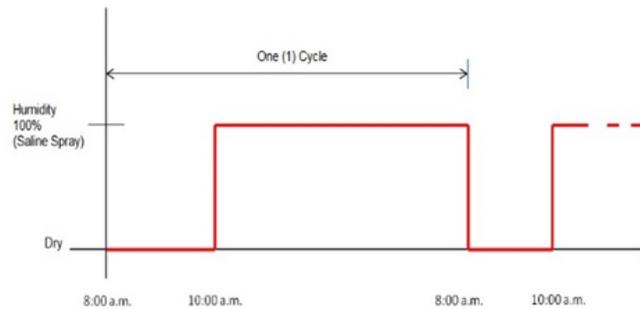
Figure 1 Exposure cycles.

During the 337.5 h of operation, the chamber maintained a constant cycle in which it had two hours of drying from 8:00 to 10:00 a.m. and the saline spray from 10:00 a.m. to 8:00 a.m. of the following day (Fig. 1). These two hours of drying were carried out to diminish the permanence of the humidity film on the metallic surface and, thus, increase the rate of corrosion.

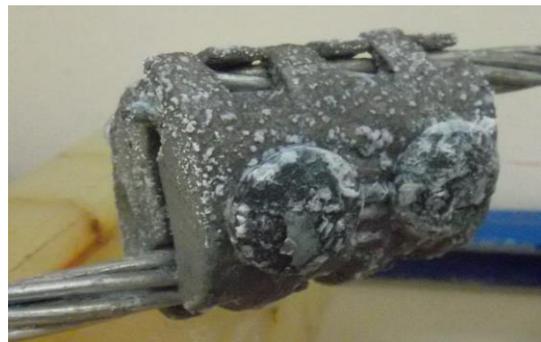
Figure 2 Specimen after 337.5 h of exposure to the saline fog.

Figures 2 and 3 show, on the metallic surface of the samples, the layers of contaminants; in this case, NaCl residues and the presence of corrosion.

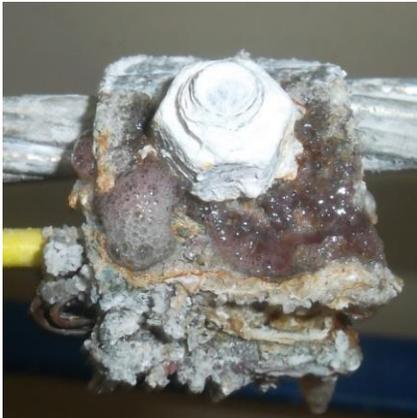
Figure 3 Samples after 337.5 h of exposure to saline fog.

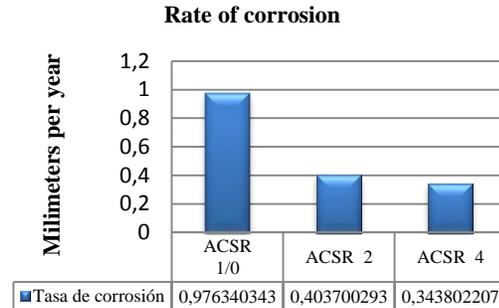
Figure 4 Average rate of corrosion

The area of the #4 ACSR was 316.3279 cm²; its initial mass was 97.1934 g, and the final mass after scaling was 96.06 g; lastly, density was at 2.705 g/cm³. The mean rate of corrosion was 0.343802207 millimeters per year.

The gauge #2 ACSR showed an area of 282.8465959 cm², initial mass of 159.99 g, and final mass of 158.8 g. The rate

of corrosion was 0.403700293 MPa. A = 265.2262063 cm², initial mass of 179.3887 g, final mass of 179.69 g, and for

the #1/0 gauge the rate of corrosion was 0.976340343 MPa (Fig. 4). Small pits on the aluminum and degradation of the zinc film on the steel were observed via BX46 optical microscope (Figs. 5, 6, 7, and 8).

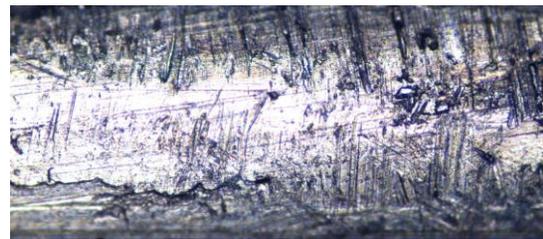
Figure 5. Aluminum before entering the SFC

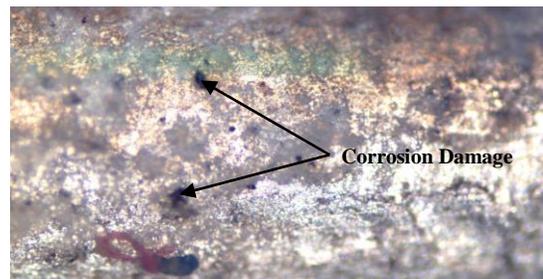
Figure 6. Aluminum after exiting the SFC

The samples, after having been subjected to corrosion during the 337.5 h, did not show major surface damage, according to that registered through the Olympus BX46 microscope. This could be attributed to the alumina layer generated when aluminum comes in contact with an oxidizing medium, like oxygen and water. It is worth mentioning that galvanized steel, which is part of the ACSR, did show important surface deterioration because the zinc layer used as corrosion protector was affected. Without this zinc layer and with more hours of exposure to the saline fog, it is likely that due to the effect of the galvanic couple between the aluminum and the steel, the steel corrodes at a higher rate.

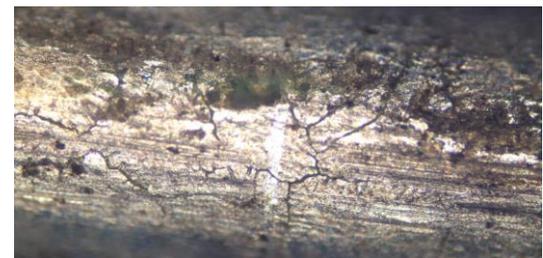
Figure 7. Steel core before exposure to the saline fog

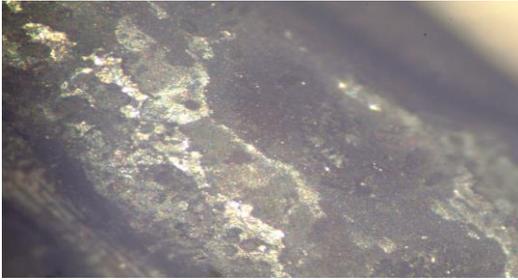
Figure 8. Steel core after exposure to the saline fog

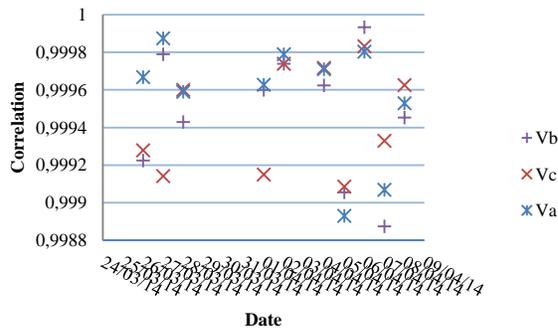
Figure 9 Input vs. output voltage correlation

The relationship of voltage with respect to current during the tests conducted with load could be observed; by correlating these two factors, an average correlation of 0.99 (0.997585893) and a standard deviation of 0.002 (0.002122663) was obtained, indicating that the test complies with the relationships that can be attributed to the electric variables in question. When comparing between input and output voltage for each phase, the results presented in Fig. 9 were obtained.

According to Table 7, an excellent degree of agreement exists among the voltages registered for each of the three phases, which ranged from a correlation coefficient of 0.998 to 1.

It is important to indicate that for day 02 April, the measurements evidenced a registry of the three phases, which were close to coinciding: V_a 0.9998, V_b 0.9997, and V_c 0.9997.

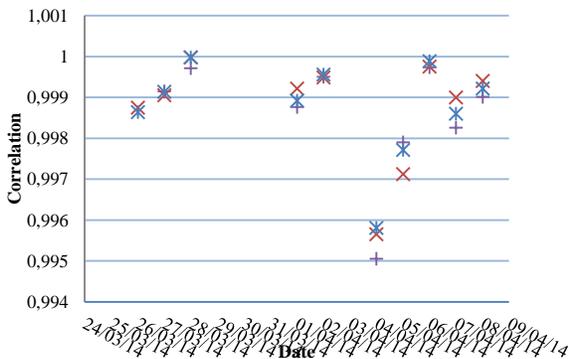
Figure 10 Input vs. output current correlation

Likewise, the input and output currents were measured and compared (Fig. 10) to minimize the variables that can affect the analysis of the test results. Until now, the tests agree with the expectations, but the input voltage is not equal to the output voltage, as with the current. Even so, a variable can explain what occurs in the system, the input voltage, and the output voltage. For this purpose, we take the actual voltage value recorded for the three phases at the input and output; the input voltage corresponds to the voltage provided by the grid, and the output voltage is that delivered to the load (Fig. 11).

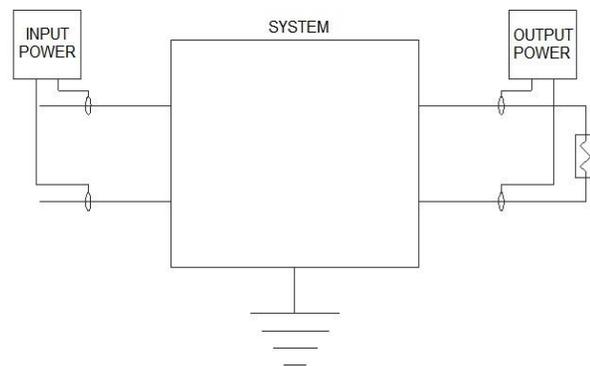
Figure 11 Power distribution

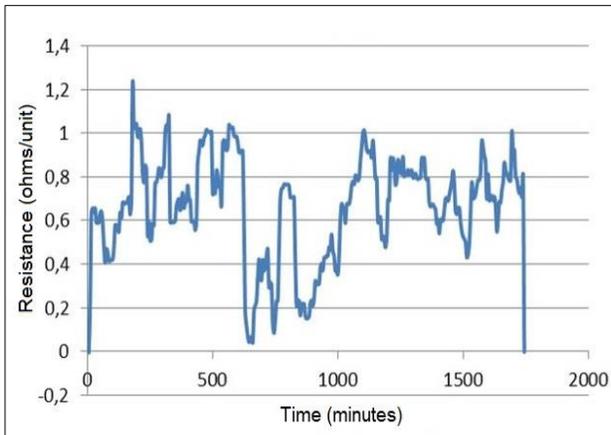
Figure 14 “mr” slope distribution of the A phase.

Given the continuity of the test, during days 07/04/2014 and 08/04/2014 the slope is calculated during one hour every 5 min to contemplate the evolution of the slope and the cut-off point during these two days. The equation of resistance in the system, where “r” represents the system’s resistance “per unit”, (R_{sist}) is the constant resistance value that represents the system, and “mr” represents the slope that controls the system’s total resistance variation over time:

By analyzing the data “per unit”, the evolution of slope (mr), which is calculated with Equation 3 and its tendency over time, evidenced in Figures 14, 15, and 16 with domain from 0 to 1800 every 5 min, would yield an estimate of the affectation of the material as time passes.

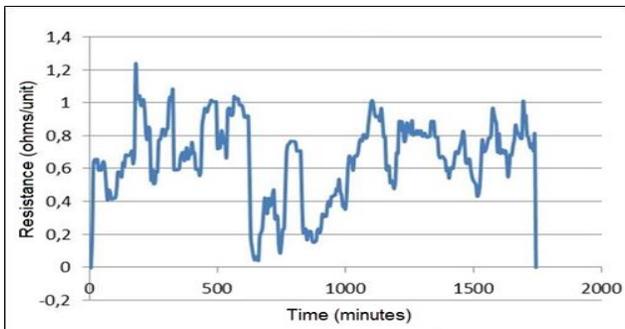
Figure 15 “mr” slope distribution of the B phase.

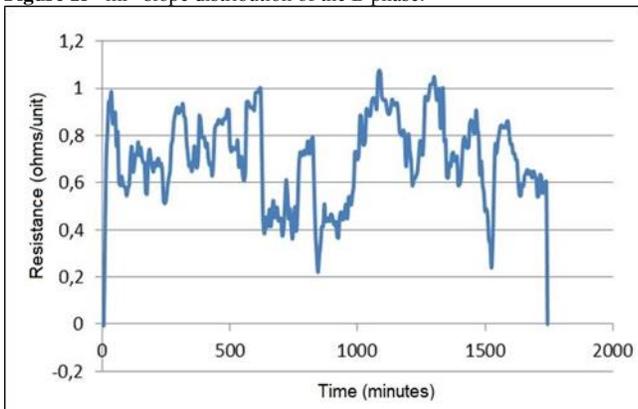
Figure 16 “mr” slope distribution of the C phase
