## Design, Development, and Evaluation of a Laboratory-Scale Phytoremediation System Using *Eichhornia Crassipes* for the Treatment of Chromium-Contaminated Waters

Uriel Fernando Carreño Sayago<sup>1\*</sup>, Carlos Arturo Granada Torres<sup>2</sup>

<sup>1</sup>Fundación Universitaria los Libertadores, Bogotá, Colombia

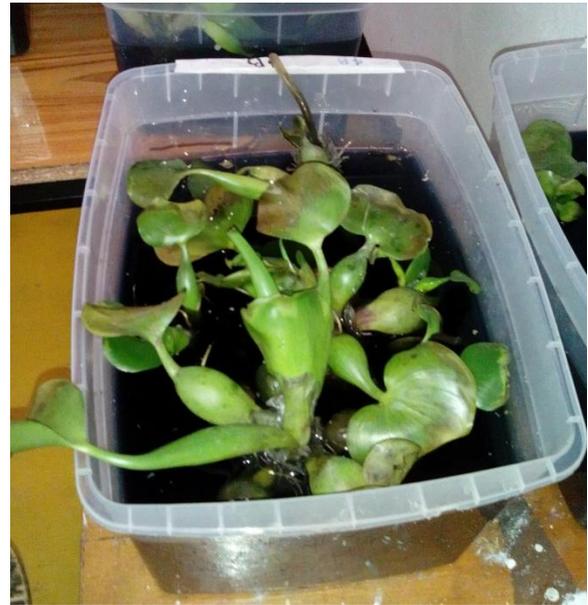
**Figure 4** Design of the treatment apparatus with its dimensions

The design of each treatment apparatus at the pilot laboratory scale consisted in adapting a resistant plastic container with the dimensions shown in Figure 4.

We used two *Eichhornia crassipes* plants for each treatment, each of which weighted 180g. As seen in Figure 4, the dimensions of this treatment apparatus are: 40 cm in length, 17.5 cm in height and 17.5 cm in width. We also used 11.5 liters of water. This design was made at laboratory-scale.

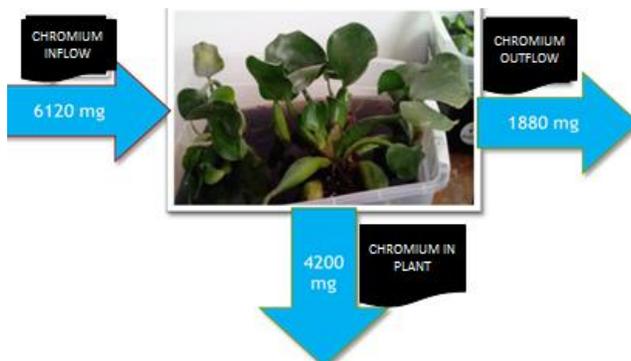
**Figure 8** Chromium Balance in experiment 2

As shown in Figure 8, there was a significant removal of chromium; *Eichhornia crassipes* retained a lot of it in its roots and leaves. 70% of the chromium present in the water was removed. This experiment could be potentiated by placing another plant to continue the removals until a permissible level of chromium is reached (one acceptable by the environmental authorities).
